ROTBLOC UTL

# Case Study

Alamon installed ROTBLOC UTL at the IBEW Local 9 Training Center in Chicago, IL, when several of their new utility poles prematurely rotted after just three years.

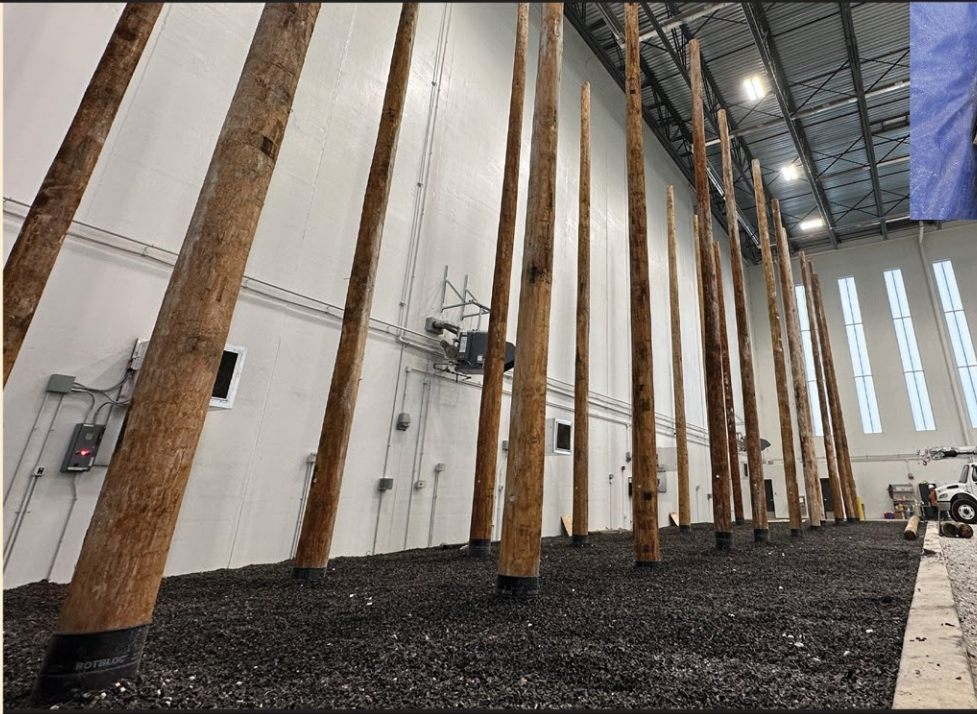
During an overhead climbing class at the IBEW Local 9 Training Center, an instructor and apprentice were injured when a three year-old pole failed at the groundline and fell over.

Kris tested the poles. You know, you screw into it on a specific angle, he’s looking at the wood shavings, he’s doing something like horse whispering (Jeff smiles, cups his hands and motions as if he’s smelling wood shavings). There’s a lot more to it, obviously. But he recognized very quickly what the issue was. Our training school sits in kind of a lowland area, and the water line is very high. When the new poles were put in, it’s like a tiki torch effect where the poles are pulling the

moisture up from underneath. And right about a foot underground where the oxygen meets the moisture is where every pole was corroded. And I was like, “okay, how can we do better?”

**Matthew Warner:** We knew ROTBLOC UTL was the answer. It’s going to shield your poles from the factors that contribute to decay. And as long as you get properly treated poles from your supplier, it’s going to trap those treatment chemicals inside that pole, and won’t allow them to leach.

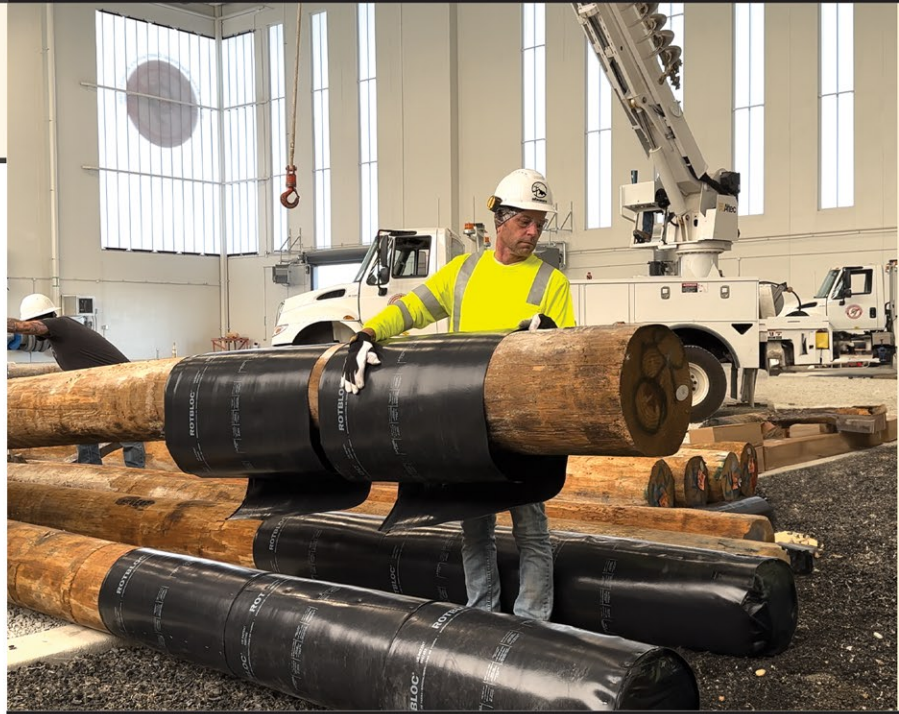
My point is that you have a high water line here at your facility, and using a butt to groundline ROTBLOC UTL wrap should make these poles bulletproof. And we'll see that proof ten years from now when we do the follow-up inspection.

We don't typically do a full wrap from butt to tip with Cu-Bor pads at the butt end, because the whole point with ROTBLOC is that it enables you to minimize chemical treatments.

But given this circumstance, we wanted every possible layer of protection and an overabundance of caution.
